## Forensic aspects of VIN location on motor vehicles

**Abstract** A vehicle identification number (VIN) is an unambiguous, globally unique vehicle identifier. The paper describes principles for its location on a vehicle, the method of its making (manufacture) and, last but not least, types of protection against negative factors to ensure that its identification value is preserved and, simultaneously, the process of identification inspection of a vehicle is clear, fast and efficient. The text analyses various views on VINs from the point of view of vehicle manufacturers, administrative bodies (that use vehicle identification in nationwide vehicle registers) and law-enforcement bodies during the investigation and gathering of evidence of car crime.

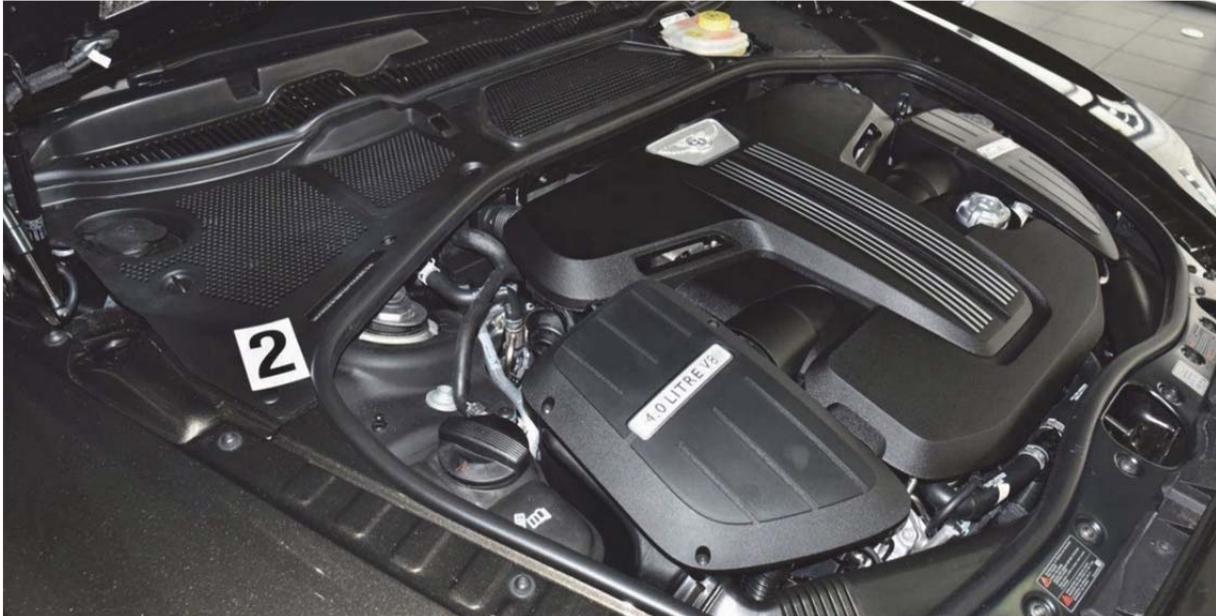
**Figure 1. A standard VIN position in the engine compartment of a Bentley Continental GT vehicle. The VIN is easily visually accessible (to the right from the number "2").**

Aside from certain exceptions, a VIN identifier located **in the engine compartment** usually tends to be well-placed, so it is visible at first sight after the engine compartment lid is opened. VINs have been placed there plentifully in the past, particularly along the upper sides of the body; in the front top part of the dividing partition between the cabin and the engine compartment. A VIN is then

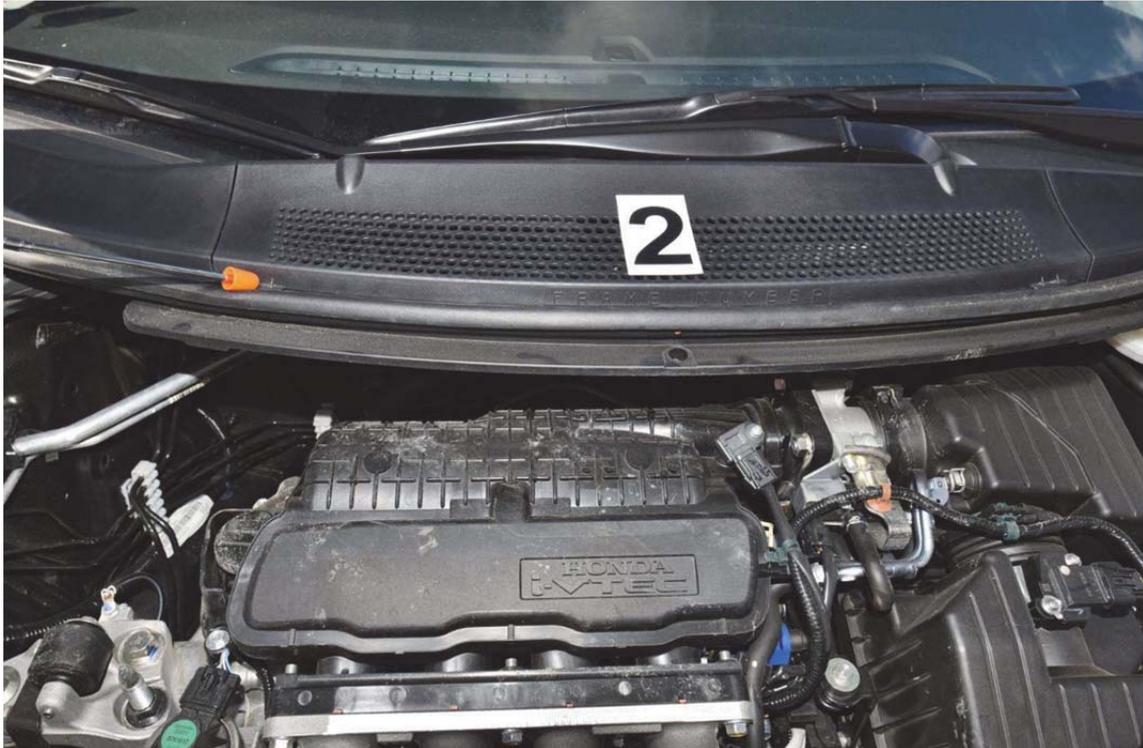
**Figure 2. Example of a difficult-to-access VIN in a Honda Civic vehicle. For the identifier to be visually accessible, plastic parts must be expertly dismantled.**

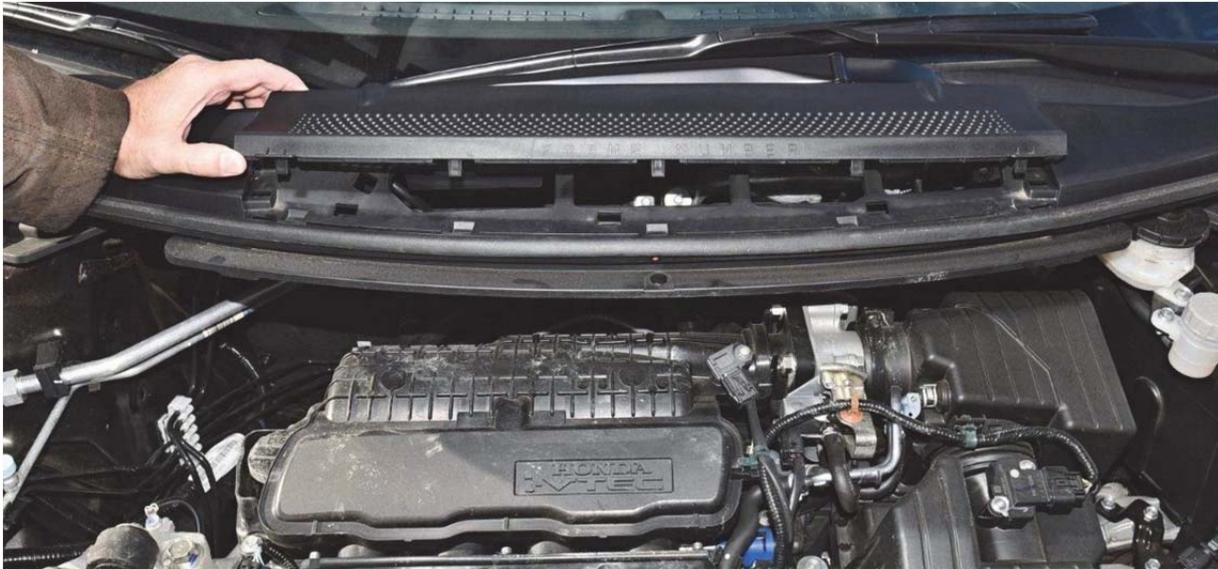
Figure 3. Demonstration of a dismantled plastic cover in the space in front of the windscreen wipers.

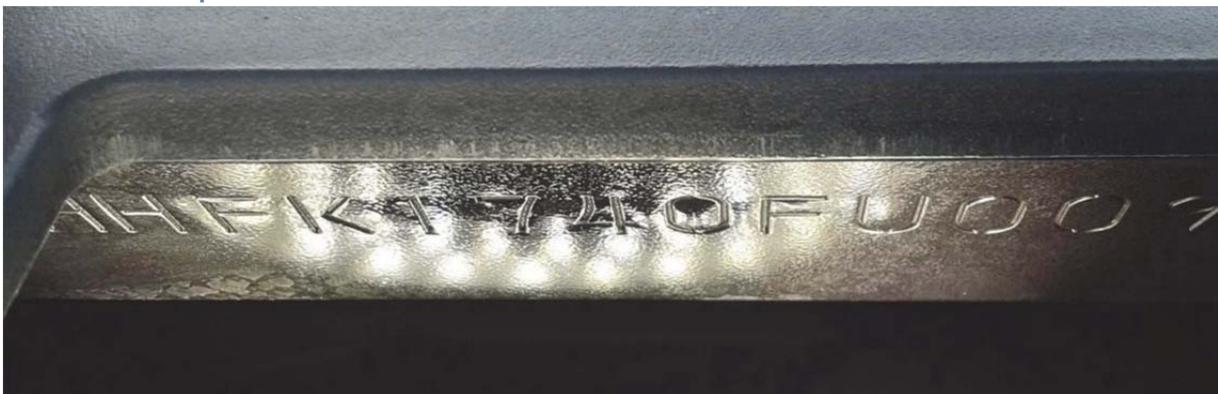
Figure 4. Overall, the identifier is visually inaccessible even following this dismantlement. Reading the VIN is very uncomfortable, and the inclined surface plays a role as well.

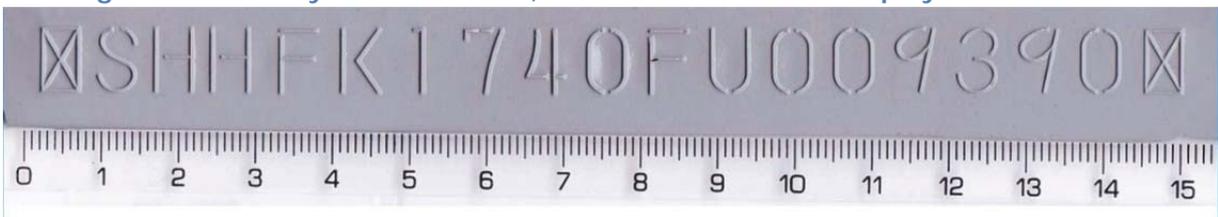
Figure 5. In forensic practice, plastic prints by means of a special compound (ISOMARK in this case) are used in such cases for documentation purposes. They are very sensitive and make it possible to observe the print in detail in its detailed form afterwards.

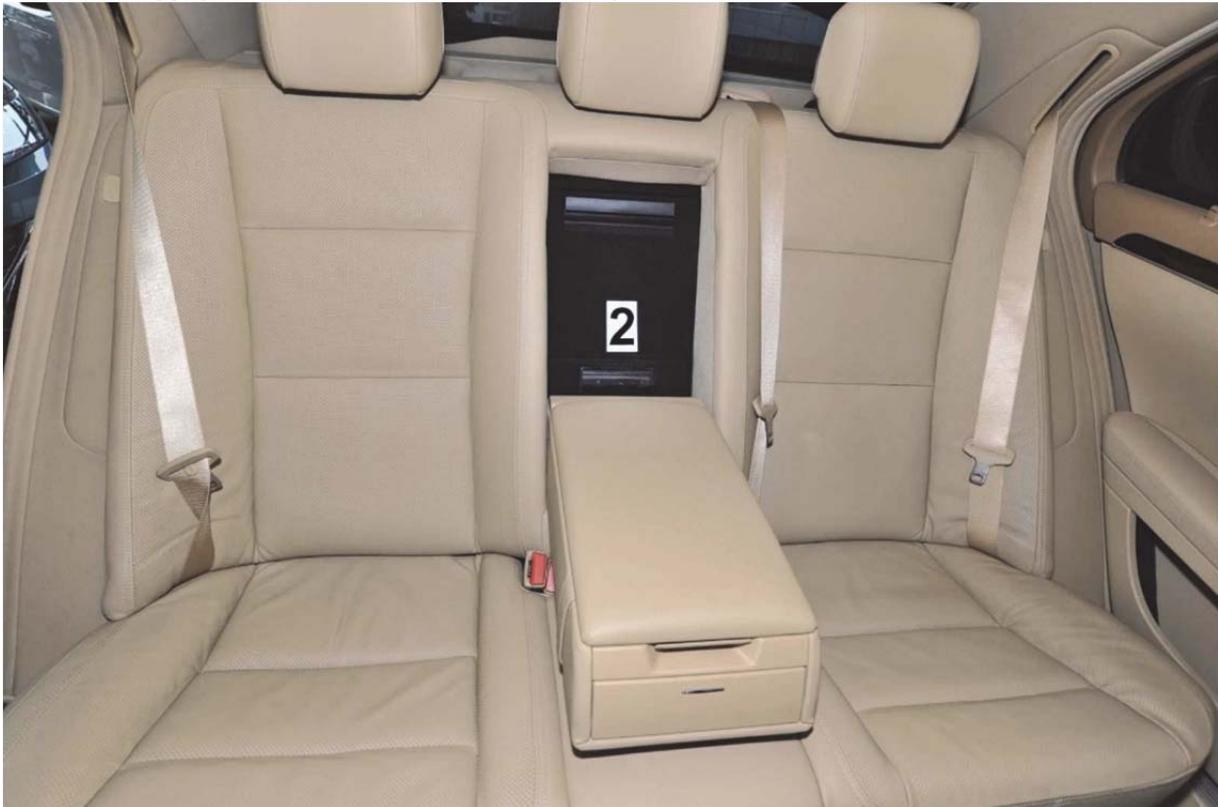
**Figure 6. A VIN located in a non-standard way in a Mercedes – Benz “S” class vehicle in the space behind the elbow rest of the rear seats. It occurs to hardly anyone to look for the identifier there. On the other hand, this space is clean, dust-free so the identifier is not exposed to the negative effects of ambient phenomena.**

Mechanical coverings of a VIN identifier are common if the VIN is executed in the floor of the vehicle (usually under the front passenger's seat) or in the inner interior part of the vehicle in the area of the A-pillar (a pillar of the body between the windshield and front door of the vehicle), in the floor of the vehicle near front passenger's legs below the dashboard or on the inside of the door frame above a wheel arch. In some vehicles, the VIN is exceptionally placed behind the folding elbow rest between the rear seats, etc.

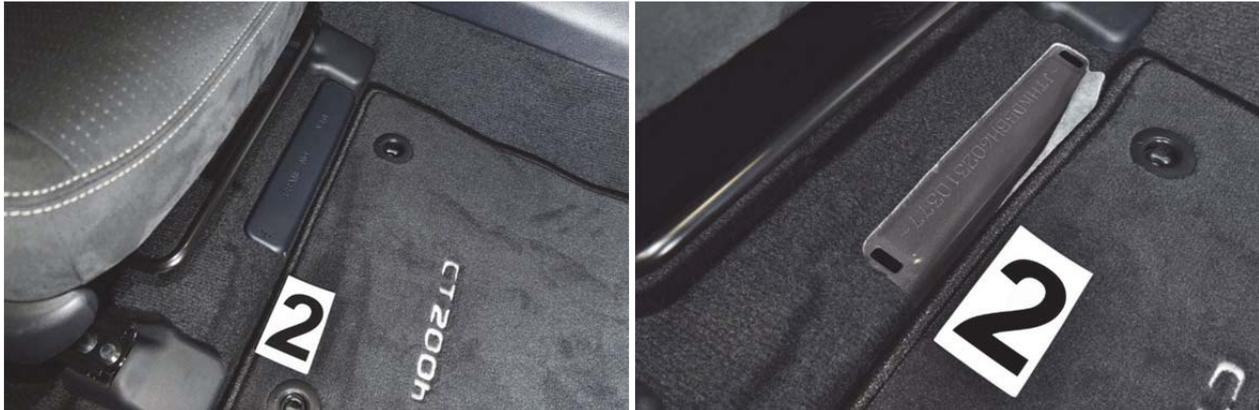
**Figure 7. The VIN of a Lexus CT 200h vehicle standardly placed below the front passenger's seat. The VIN is protected by a plastic guard against damage and soiling.**

Plastic guards (predominantly black or grey) tend to be marked with a pressed-in inscription *"VIN"* or *"frame number"*, etc., in a well-visible way. Plastic guards are designed to be easily opened without the use of great force, or should be carefully "lifted" with a tool similar to a screwdriver. Some hinged guards are slid on the access hole to the VIN, and it is thereby possible to slide them out carefully together with their plastic perimeter frame. In some specific vehicles (currently manufactured luxury Mercedes Benz S class vehicles), a plastic guard cover is used to access the vehicle's fuse box, near which a VIN is stamped on the body as well). In such cases, a VIN marking on the plastic guard is absent.

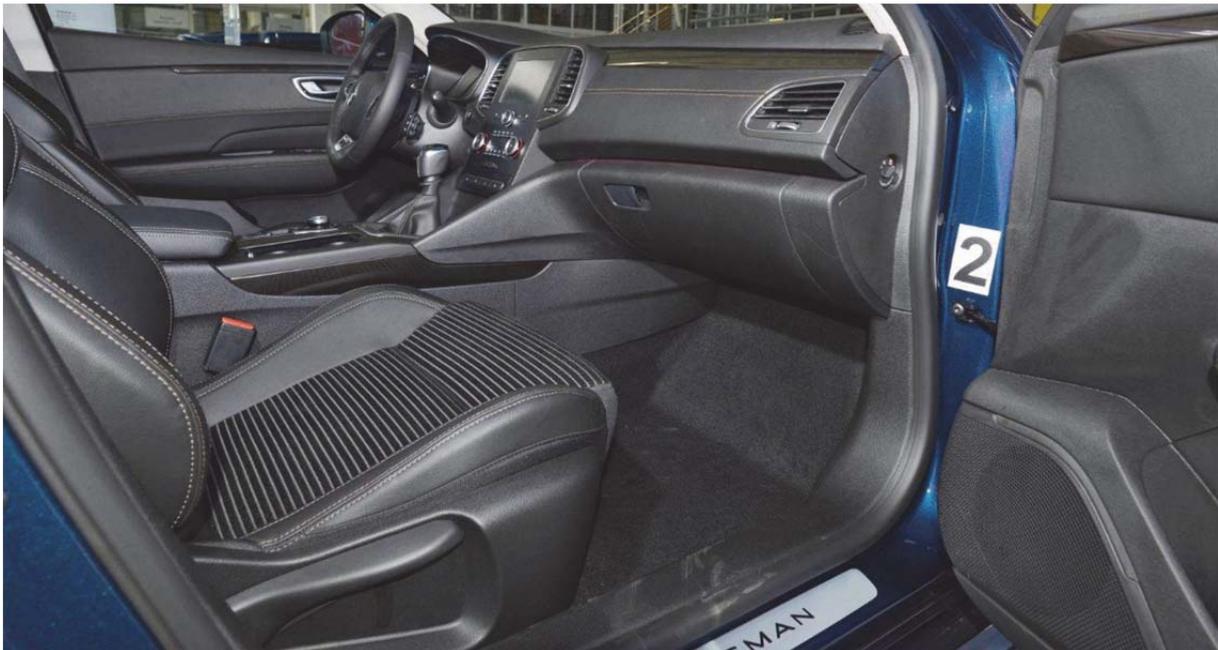
**Figure 8. Renault Talisman. The VIN is positioned unusually vertically in the space of the A-pillar. When the VIN is positioned vertically, dirt, water and service fluids do not cling to it as much.**

The extent of potential physical and chemical damage resulting from the operation of the vehicle and the external environs of the vehicle (e.g. climatic conditions) is also decided by the selection of a horizontal or vertical position of the VIN identifier as well as of other similar identifiers: water and service fluids better flow down vertical surfaces, and dust deposits are less likely to remain there, so the degree of fouling is substantially lower in practice than with identifiers that are placed on horizontal surfaces. With respect to horizontal surfaces, it is appropriate to use various protective coverings with transparent films, the application of various protective paints, wax layers, etc. To better protect the VIN against corrosion, some manufacturers position the identifier vertically into the front ("A") pillar of the vehicle (some Renault and Dacia models).

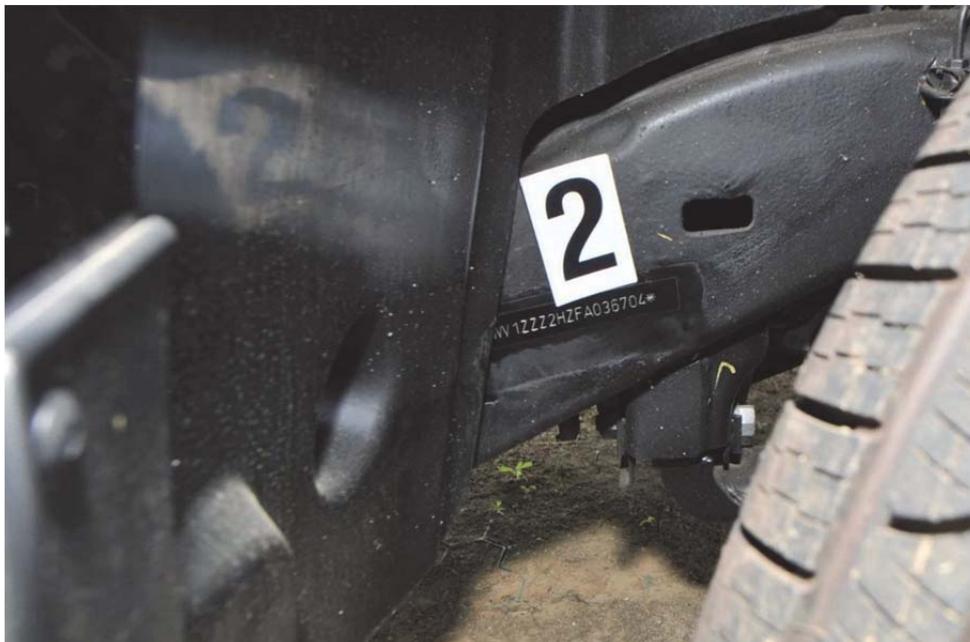
**Figure 9. Volkswagen Amarok. The VIN identifier is located outside the vehicle on its chassis part and is protected by a transparent cover label. Placing the VIN in this part of the vehicle is not too fortunate – comfortable for practical inspection (one has to bend down and, at the same time, turn the wheels), the vehicle chassis tends to be very heavily fouled, so one has to know exactly where to look for the identifier. After several years of operation, the identifier is severely corroded, so its legibility decreases abruptly.**

A VIN identifier is more susceptible to corrosion the lower it is placed towards the roadway on an exterior part of the vehicle. Thus, it is exposed to the greatest corrosion if it is stamped into the frame of the vehicle in its chassis part and, at the same time, it is not provided with any further special protection. Some vehicle manufacturers make a VIN identifier without even spraying a bare minimum primer over it.

Fortunately, such approaches rather belong to the past, though. At the present time, an identifier on the vehicle's exterior is normally protected by asphalt-rubber or wax or resin protective sprayed coats, or coatings or protective layers applied in another way.
